ENVIRONMENTAL EVOLUTION OF THE FITCH BAY WATERSHED

Final Report

By
MAP² Environmental Consultants

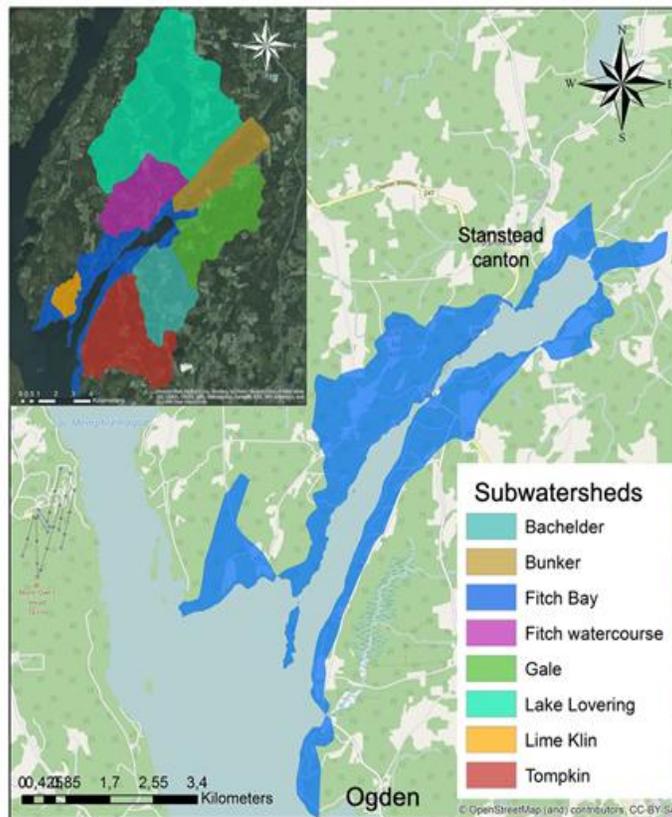
Figure 1.1: Map delineating the main study area (Source: MCI)

The study area covers a surface of 1472 hectares, dominated by forests. Agriculture and farming lands, in addition to residential areas, also occupy parts of the region.

While certain aspects of the present analysis extend outside this area, most of the impacts can be seen in the central Bay area. Therefore, we focused on Fitch Bay subwatershed (Fig. 1.1) with some additional information integrated from adjacent locations to provide a better understanding of the environmental evolution.

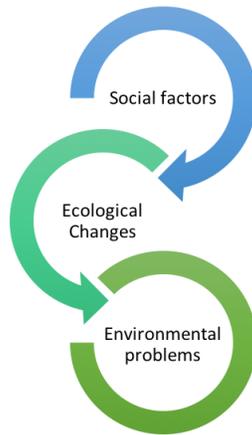
Figure 1.2: The steps of historical analyses. Adapted from Ali and al., 2017

To understand a territory's evolution, it is necessary to study the social and ecological changes as they often are the leading causes for environmental damage (Figure 1.2). In the social component, we found laws that affected the area, such as pesticides, population changes, land value, knowledge of the problems and the institutions monitoring them. The ecological section includes water quality, species variation, and land use changes. This information was found mainly in archives or can be obtained by scientific methods such as soil core analyses.

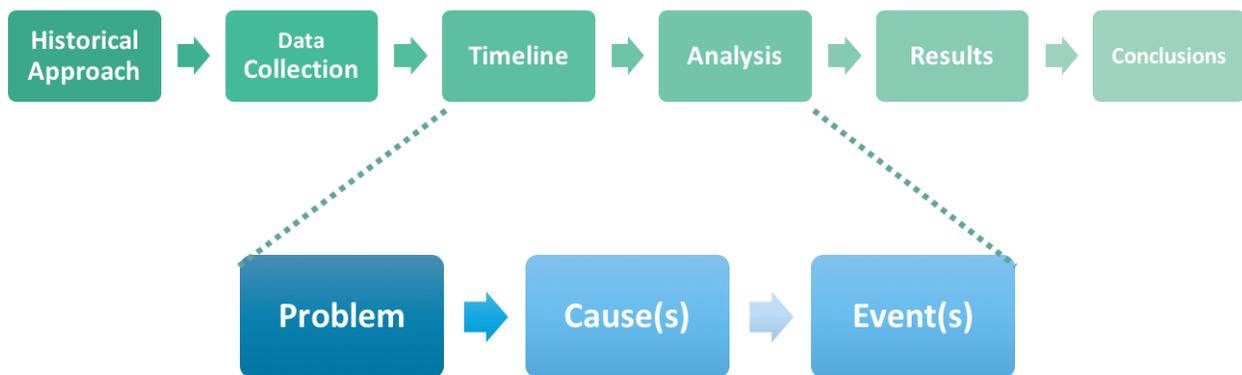
Figure 1.3: Methodological approach used in this project.

Our methodology consisted of three main steps. First, all available data (qualitative and quantitative) were assembled separately for each area of interest. This step consisted of finding events that have possibly affected the environment of our area. Secondly, events found in the first step were Assembled into a timeline. Added to scientific research on the most important environmental issues of the Bay, the timeline shows the eventual connexions

between events. These were traced back through time to allow a better interpretation of major key events that affected this environment in different periods.

Challenges faced during this project were mostly related to data availability and time constraints. The methodology described in this work (Figure 1.3) can be applied in future studies on the Fitch Bay watershed to improve the appreciation of the environmental issues of that area.

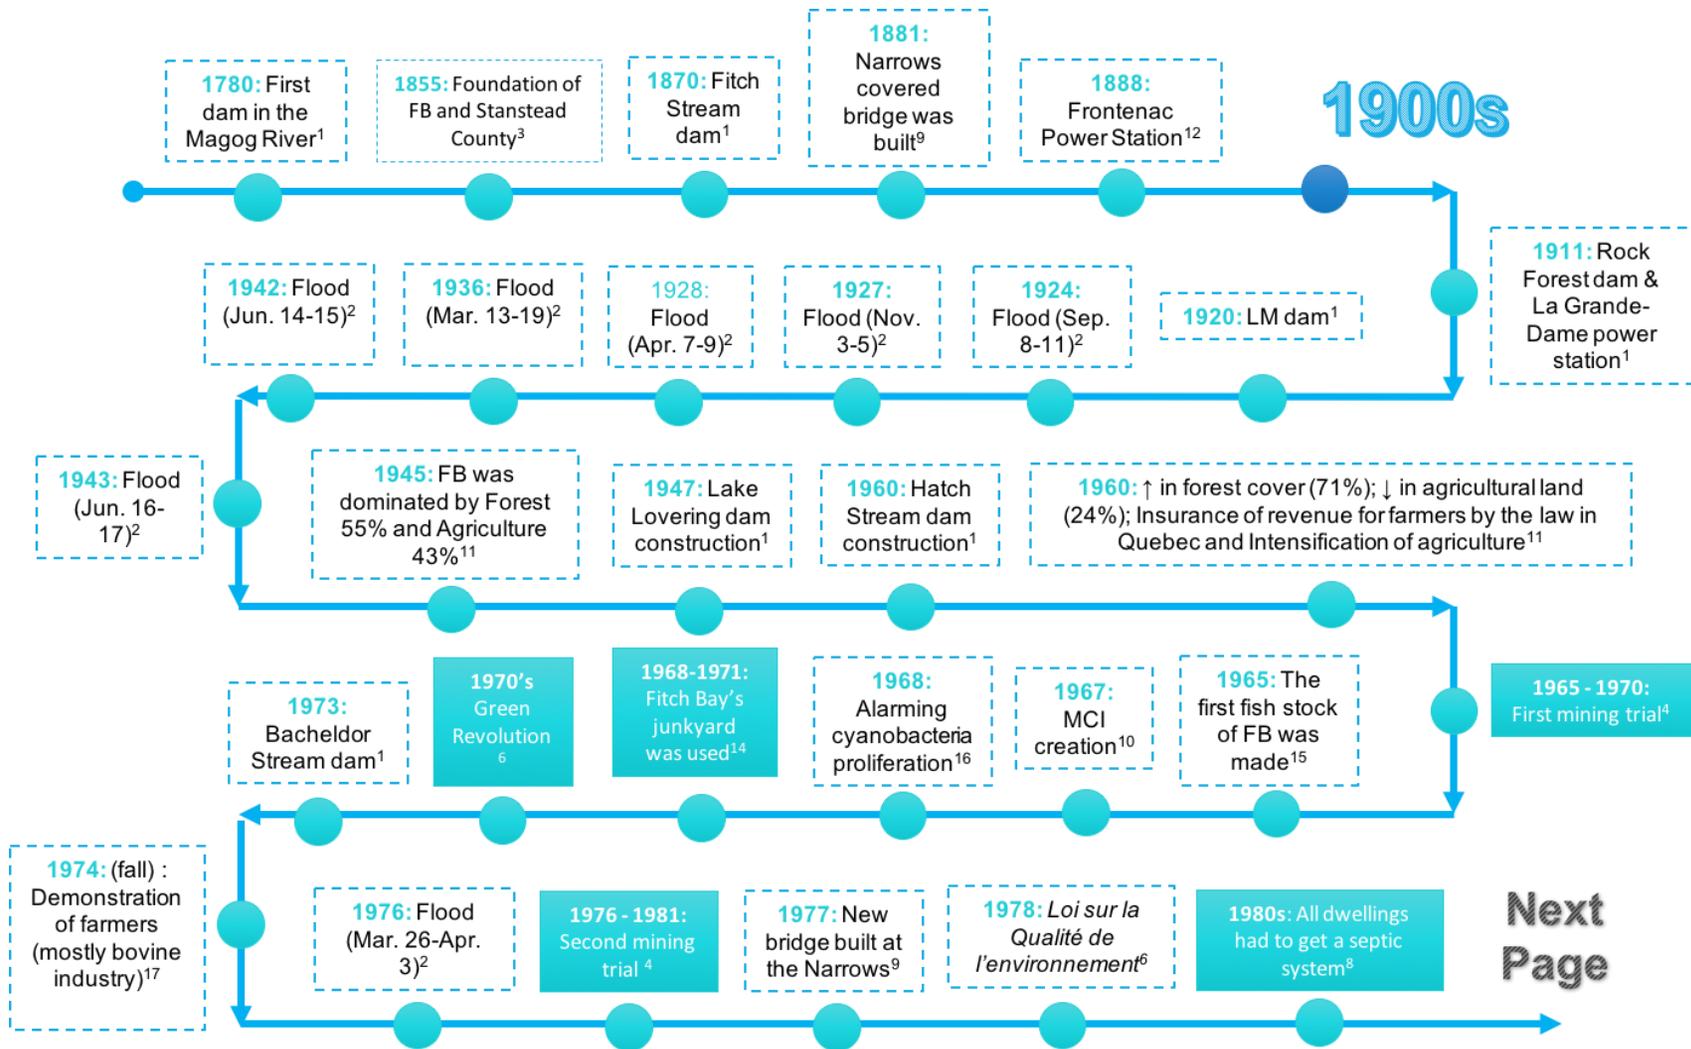
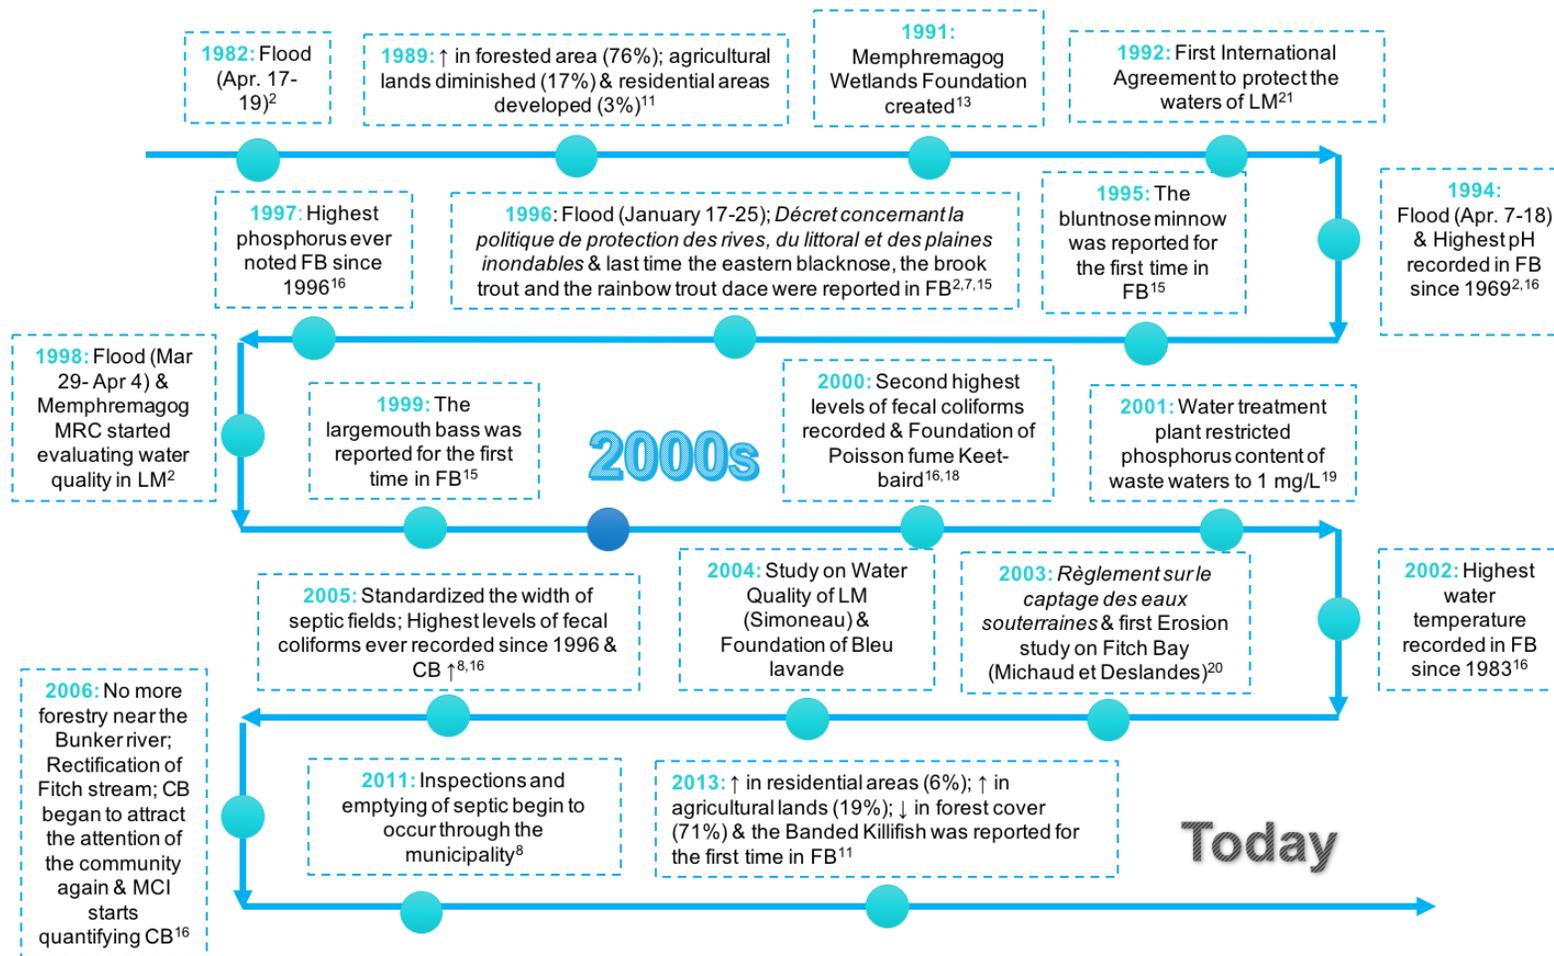
2.2 Timeline

Abbreviations: Cyanobacteria Blooms (CB), Fitch Bay (FB), Lake Memphremagog (LM), and Memphremagog conservation inc (MCI). The events in the light blue boxes lasted more than a year.

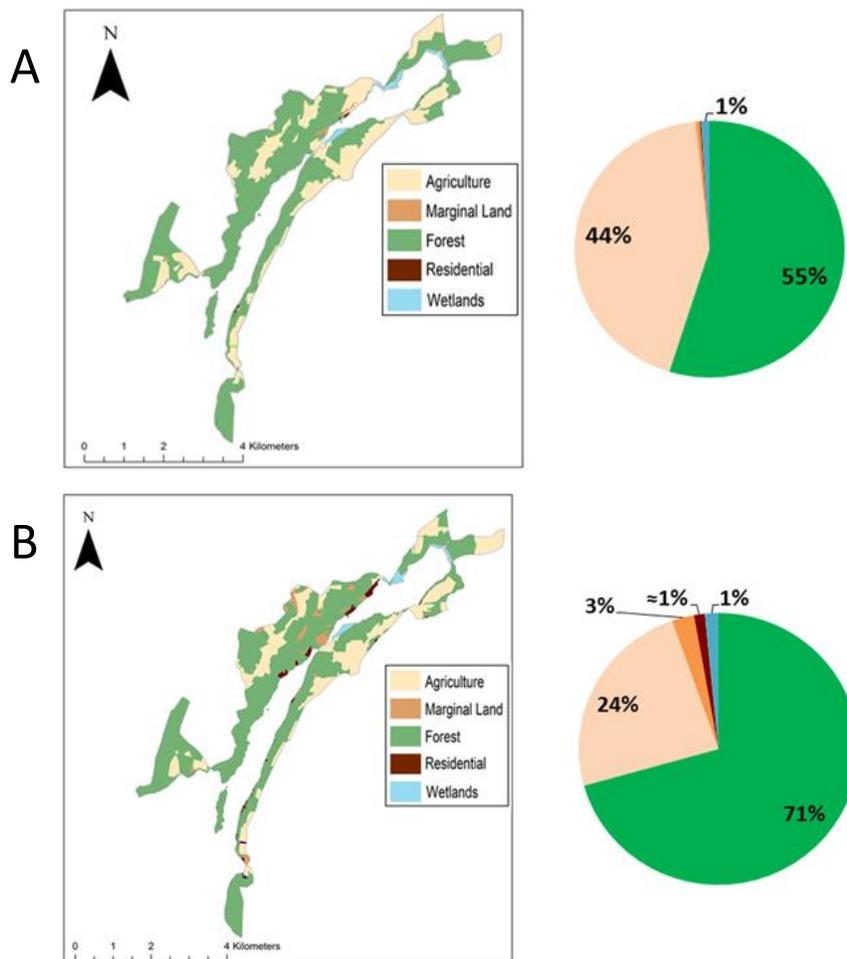
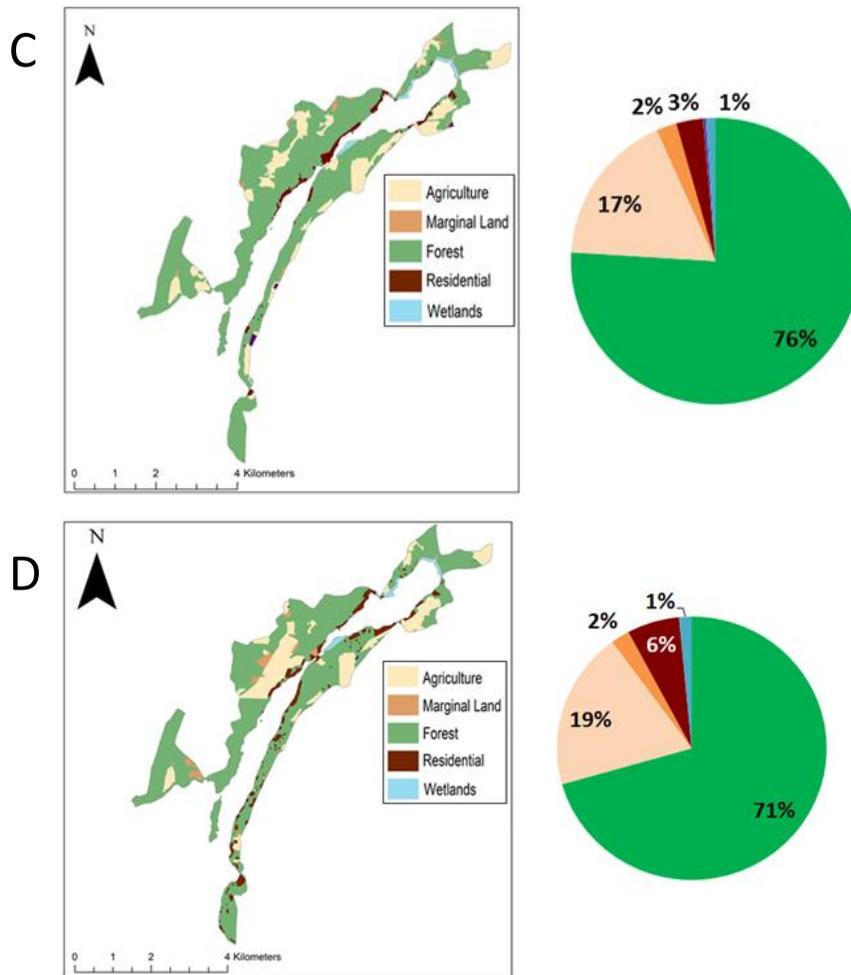
Figure 3.1: Land use maps and pie charts showing the evolution of space occupied by agriculture, wild land, forests, residential, and wetlands. Images correspond to 1945 (a), 1960 (b), 1989 (c), and 2013 (d).

Fitch Bay is located on what were mainly forests with a few wetlands. The Northwest part of the bay used to be a marsh that was submerged when the first dam was built, creating the Bay that distinguishes the region today. By 1945, nearly 44% of this land had been converted for agriculture, mainly north of the Narrows, leaving only 55% of forests untouched. Some years before 1960, many small farms were forgotten, becoming wild land and eventually returning to a forested state. Agriculture was reduced to a mere 24%, dropping further to 17% by 1989. At this time, there was also a 2% increase in residential use on the Bay's northern shore. Residential occupancies doubled by 2013, now representing a

total of 6% of the landscape. Populated regions extended beyond the shoreline to previously forested areas east of the Bay. Some were built in proximity to wetlands threatening the integrity of these fragile ecosystems. This urban sprawl is commonly labeled as the starting point of several environmental problems in Fitch Bay.

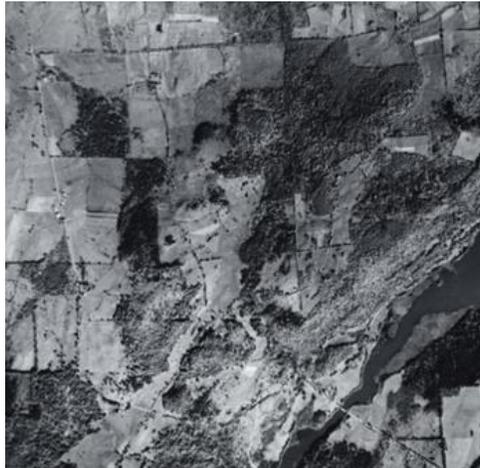
Figure 4.1: Aerial view of a portion of the agricultural land present in 1945, by the Fitch Bay Narrows. (Source: Géomathèque of the Université de Sherbrooke, A9426-65, 1945, scale 1: 20000)

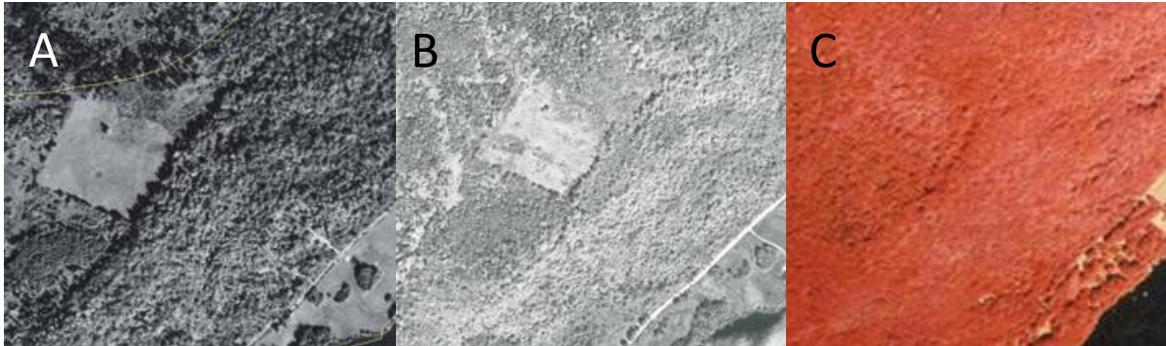
Figure 4.2: Aerial images showing forest regeneration as agricultural land ((a)1945) is abandoned ((b)1960) and turned back into a forest ((c)1989). (Source: Géomathèque of the Université de Sherbrooke, A9426-65, 1945, scale 1: 20000; R1323-100, 1960, scale 1: 15840; Q89105-141, 1989, scale 1: 15000)

When these soils are covered with trees or dense vegetation, they can resist erosion; but when the landscape is transformed, problems surface rapidly. Forest is the natural state of this ecosystem and any variation will increase erosion. When settlers first arrived in the 1850s, the land was transformed for agriculture, no matter the soil fertility. In the 1860s, the American Civil War led to the development of forestry in the region, which continued until 2006. Over the first years, there were large transformations in the area, leading to the beginning of erosion processes. Within 100 years, many farms and logging industries closed, allowing the forest to regenerate (Figure 4.2). The erosion of surrounding lands

into the streams and surrounding waters most likely decreased as farms further from the streams were overgrown.

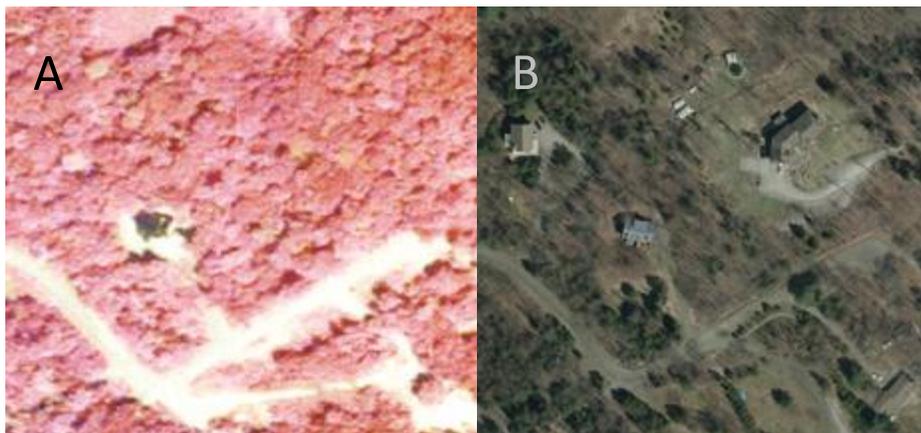
Figure 4.3: Aerial views from 1989 (a) and 2013 (b) showing the rapid expansion of residential areas. (Source: Géomathèque of the Université de Sherbrooke, Q89105-142, 1989, scale 1: 15000; Orthophotographies mosaic 1331h01, 2013)

Unfortunately, most erosion occurs on slopes near and around the water's edge. When people sold their farms, many moved to the residential areas surrounding the Bay (Figure 4.3). Since the 1980s, this area has been developing rapidly, cutting trees and grasses in the floodplain and increasing risks of erosion. Shorelines were built up to slow erosion when in fact they increase it. Boats and other activities can also increase wave action leading to the same undesired effect.

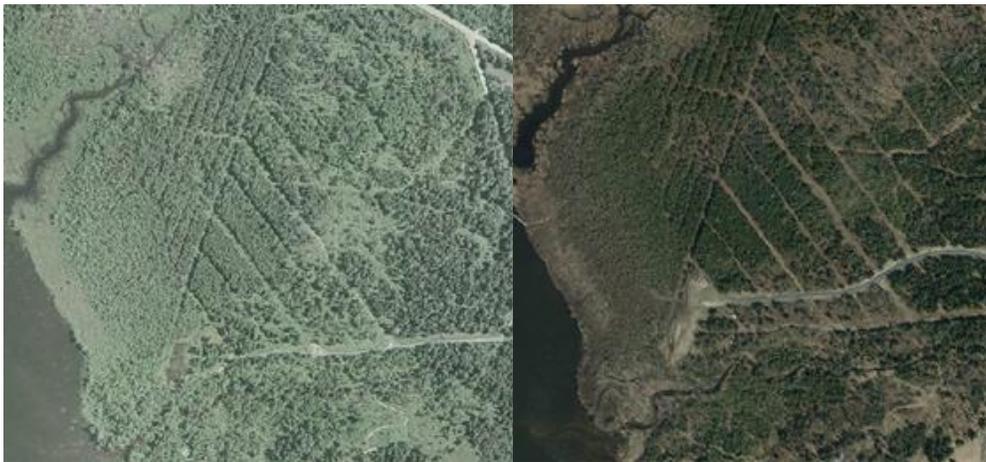
Figure 4.4: Forest cutting between the Bunker and Gale watercourses. (Source: Géomathèque of the Université de Sherbrooke, orthophotographies mosaic 1313h01, 2007 & 2013) Common activity over the past two decades. Both could have carried many sediments into Fitch Bay. (MCI, 2006)

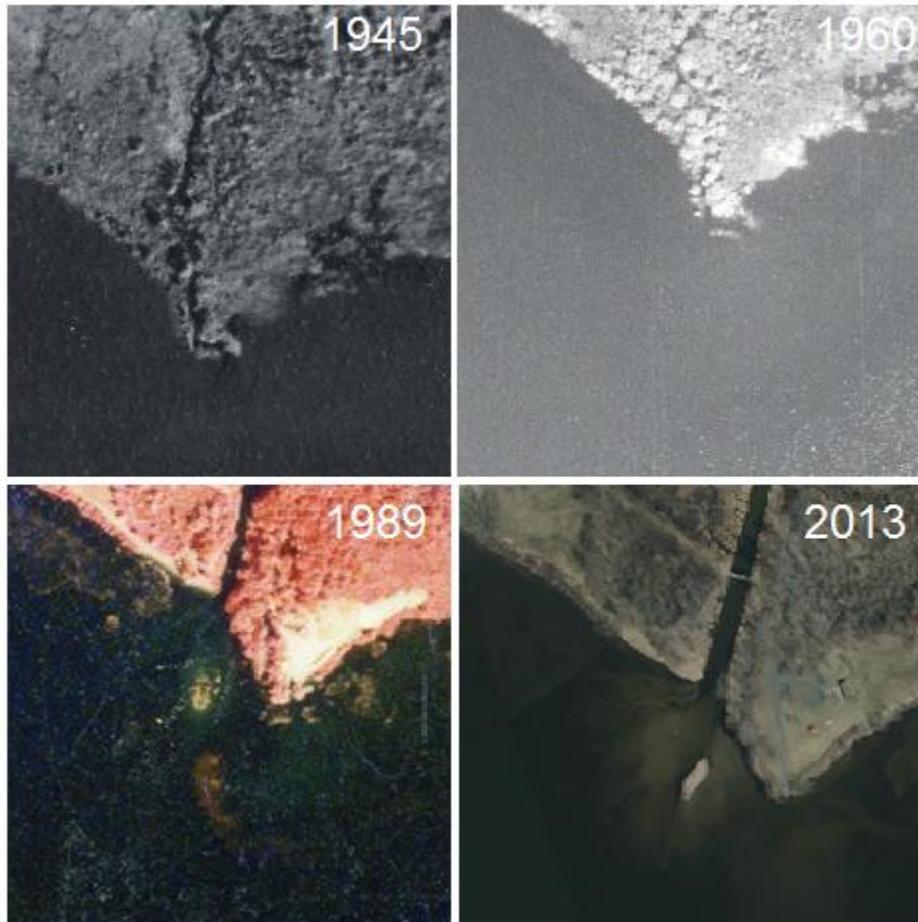
Figure 4.5: Aerial images of the rectification in the Fitch watercourse and formation of the delta. (Source: Géomathèque of the Université de Sherbrooke, A9426-67, 1945, scale 1: 20000; R1323-100, 1960, scale 1: 15840; Q89105-141, 1989, scale 1: 15000; orthophotographies mosaic 1331H01, 2013)

Sedimentation was first noticed when dams were built. Downstream, waters have more speed and a better ability to erode surfaces, whereas upstream, waters are slowed allowing for precipitation of heavier materials. Therefore, dams built on the Magog River slow waters as they drain from Fitch Bay into Lake Memphremagog. Major flooding events are also known contributors as they carry more materials than normal. Once they get to the Bay, everything slows down. The rectification of the Fitch watercourse has increased sedimentation rates into the Bay as waters carry more materials. This case is visible by the formation of a delta at the inlet in Fitch Bay (Figure 4.5).
